NATURAL EXPOSURE OF SELECTED GRAPHITE/EPOXY  
COMPOSITE MATERIAL SYSTEMS

R. E. TRABOCCO  
Aircraft and Crew Systems Technology Directorate  
NAVAL AIR DEVELOPMENT CENTER  
Warminster, Pennsylvania 18974

31 JULY 1980

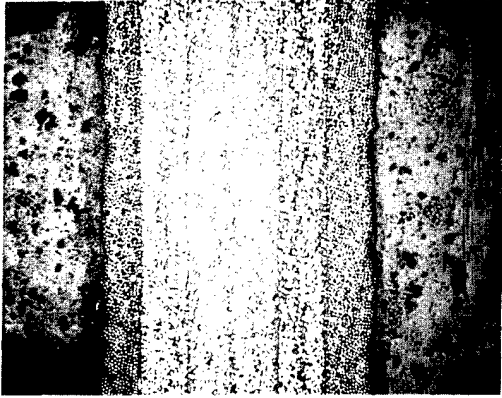
A. 100 SERIES MATERIAL

EXPOSED 36 MONTHS IN PANAMA

FIGURE 36 A COMPARISON OF UNCOATED EXPOSED AND UNEXPOSED LAMINATE MICROSTRUCTURES (35X)
